**Project of Revalorization and Extension
of the Historic Monastery Complex of St Sigismund's Parish
in Częstochowa (Poland) — A Case Study***N. Sołkiewicz-Kos, N. V. Kazhar, M. Zadworny*Politechnika Częstochowska,
69, ul. J. H. Dąbrowskiego, Częstochowa, 42-201, Republic of Poland

Revalorization of the sacral complex — case study

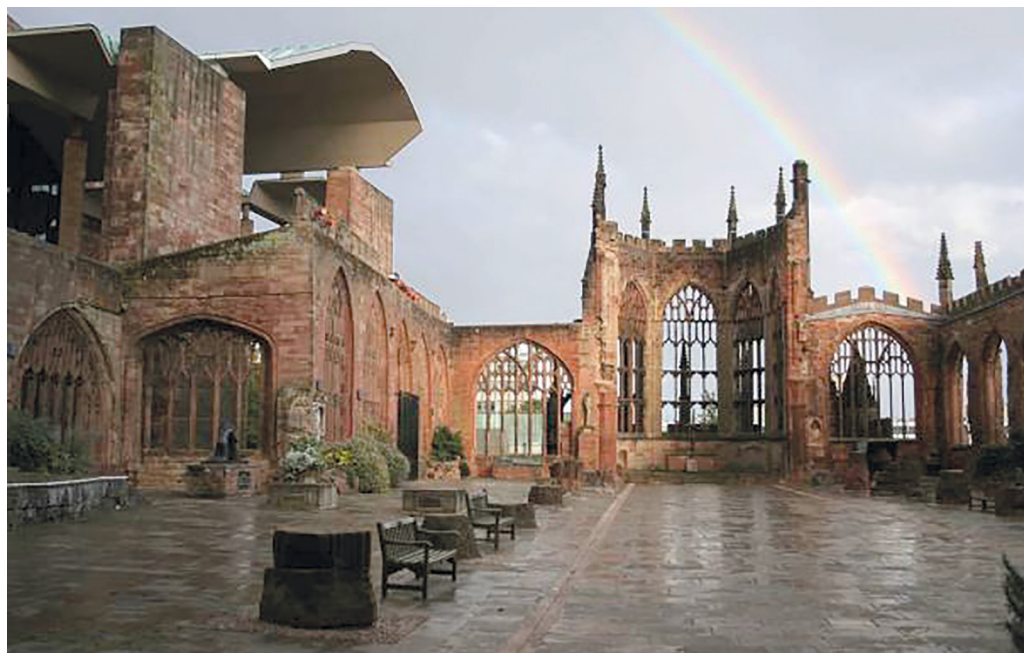
Fig. 1. Cathedral in Coventry. Example of the remaining of the monument in the form of “ruins”. Photo by Andrew Walker. https://upload.wikimedia.org/wikipedia/commons/7/79/Coventry_Cathedral_Ruins_with_Rainbow_edit.jpg

- conversion of the remains of a historic building into a ruined monument (fig. 1);
- full restoration of a monument;
- analysis of the remaining tissue of ruined buildings and reconstruction of monuments 'in situ' [1; 4, p. 8–9] (fig. 2, fig. 3).

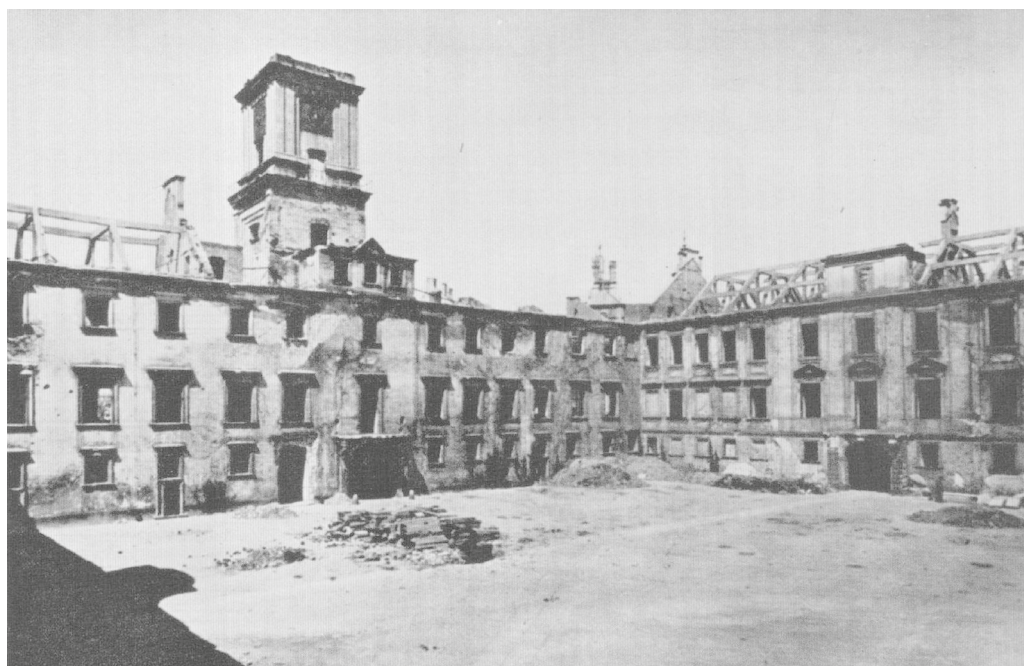
Fig. 2. The Royal Castle in Warsaw in 1941. Without roofs, intentionally removed by the Germans in order to accelerate the devastation process. process. Author of the photo is unknown. https://upload.wikimedia.org/wikipedia/commons/5/50/Castle_Warsaw_1941.JPG

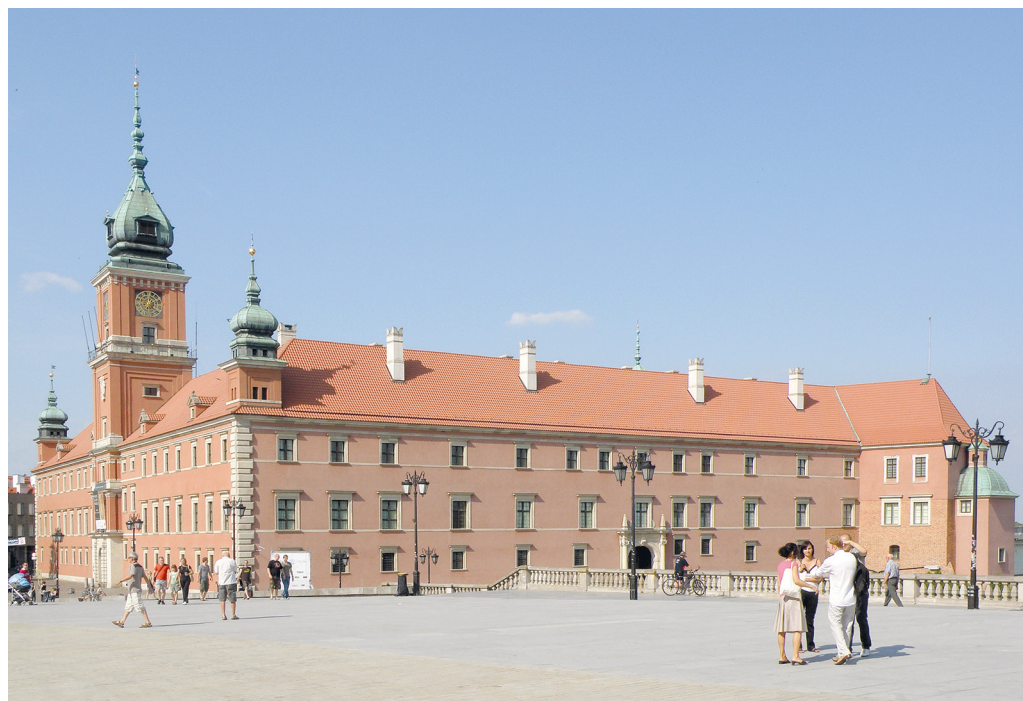
Fig. 3. Warsaw. Royal Castle after reconstruction (1971–1984). Photo by Alina Zienowicz.
https://upload.wikimedia.org/wikipedia/commons/9/90/POL_Warsaw_Royal_Castle_2008_%283%29.JPG

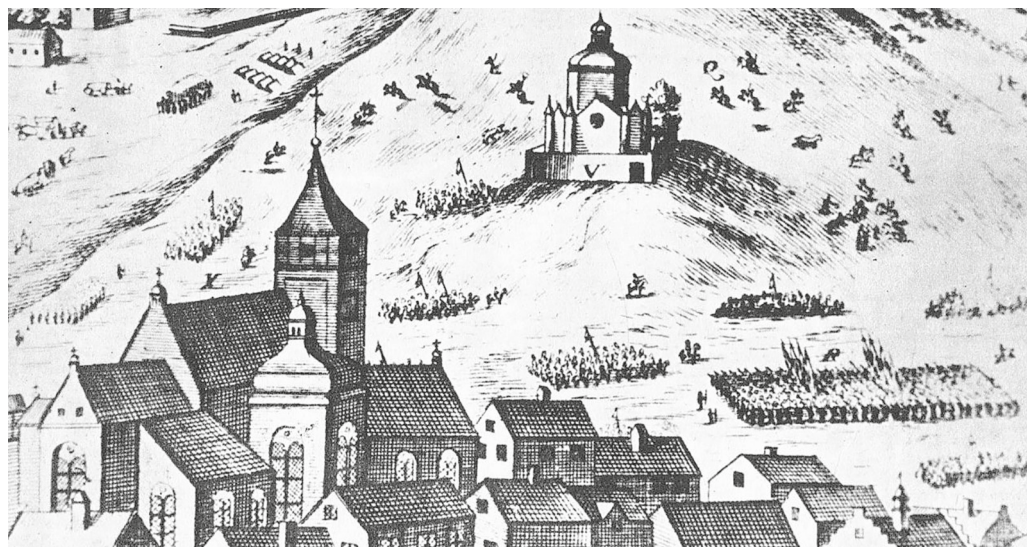
Fig. 5. Buildings of the old town. Fragment of Jan Bensheimer's engraving from 1659 [16]

church stood a stone belfry (fig. 5, fig. 6) [21, p. 23–32]. In Gorczyn's engraving a massive two-story monastery building with a tower topped with a dome is visible next to the church. It was the rectory of the parish of Częstochowa, and at the same time a monastery, intended for distinguished monks (see: fig. 6).

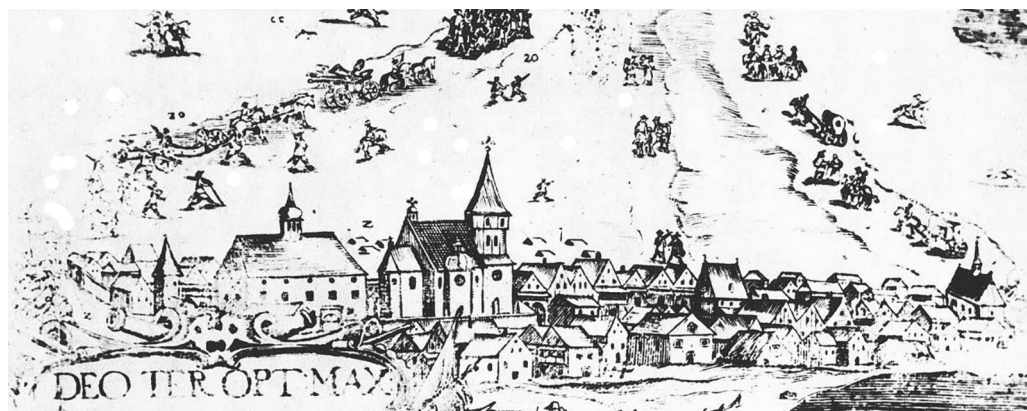
Fig. 6. A fragment of Jan Aleksander Gorczyn's engraving from 1655 [16]. Next to the church there is a massive, two-story monastery building with a tower topped with a cupola

A fairly accurate picture of St Sigismund's church after the construction of St Anne's chapel and sacristy is given to us by the engravings of Bensheimer and Gorczyn. On these drawings, which differ in details, the body of the church is well outlined, with one tower and a chapel added to the northern nave and covered with a cupola with a lantern. By the

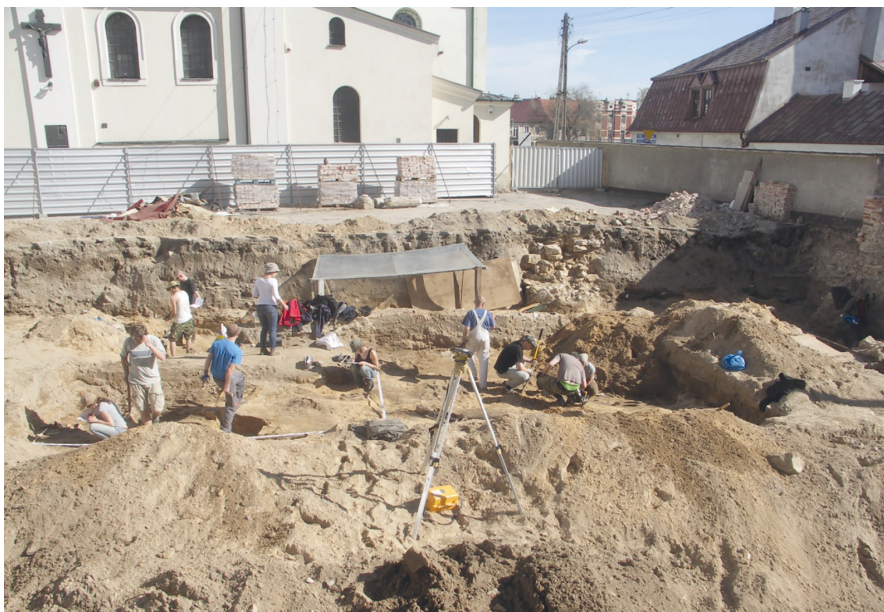
Fig. 7. Archaeological works in the necropolis. During the excavations 1053 graves containing 1220 skeletons were uncovered. Photo by M. Błażewicz

The excavated fragment of the necropolis was a remnant of the parish cemetery functioning at the St Sigismund's Church in the 16th–17th centuries. During the excavations 1053 graves containing 1220 skeletons were uncovered (fig. 7, fig. 8). Double and mass burials were found, which was explained by the probability of an epidemic or some infectious disease. Numerous objects connected with religious cult were found in the graves: medallions with the image of the Madonna and the Child, reliquaries with the image of St Mary or a saint, metal crosses, beads. The skeletons found during the archaeological research were examined by an anthropologist. The bones of the skeletons were put in a common grave in the cemetery "Kule" in Częstochowa that is administered by the church authorities [III].

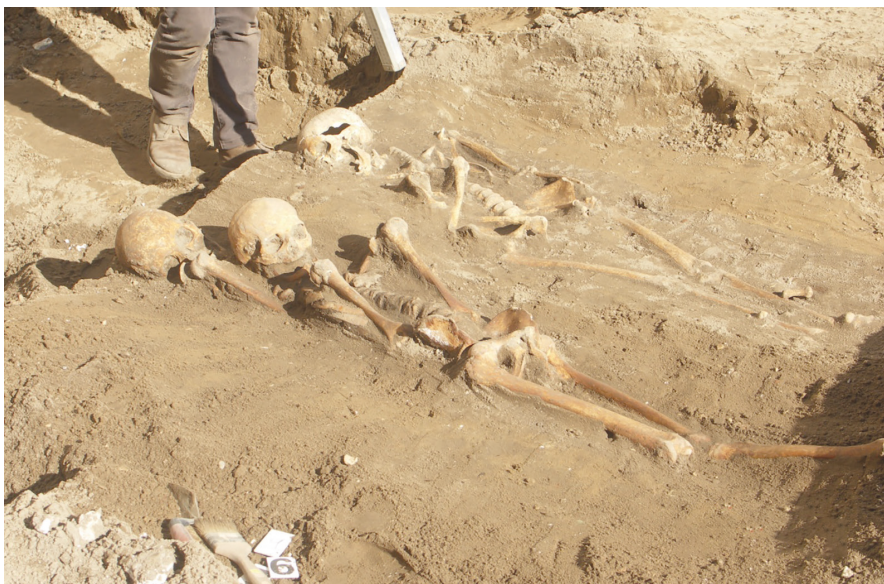
Fig. 8. Archaeological works in the necropolis. Mass burials were explained by the occurrence of an epidemic or some infectious disease. Photo by M. Błażewicz

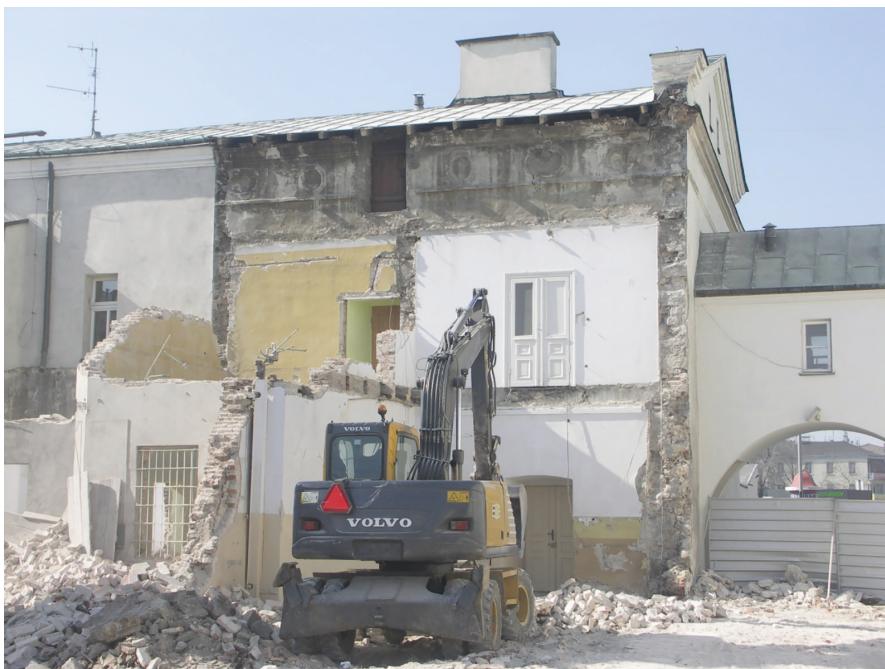
Fig. 9. Demolition of structures in poor condition that were added in the 19th and 20th centuries. The detail of the cornice in the historic monastery building was uncovered. Photo by M. Błażewicz

In the next stage, an achitectonic inventory of the objects was carried out in order to identify their historic values. The analysis of the object inventory (without excavations) allowed only to identify the buildings added in the 19th and 20th centuries (fig. 9, fig. 10).

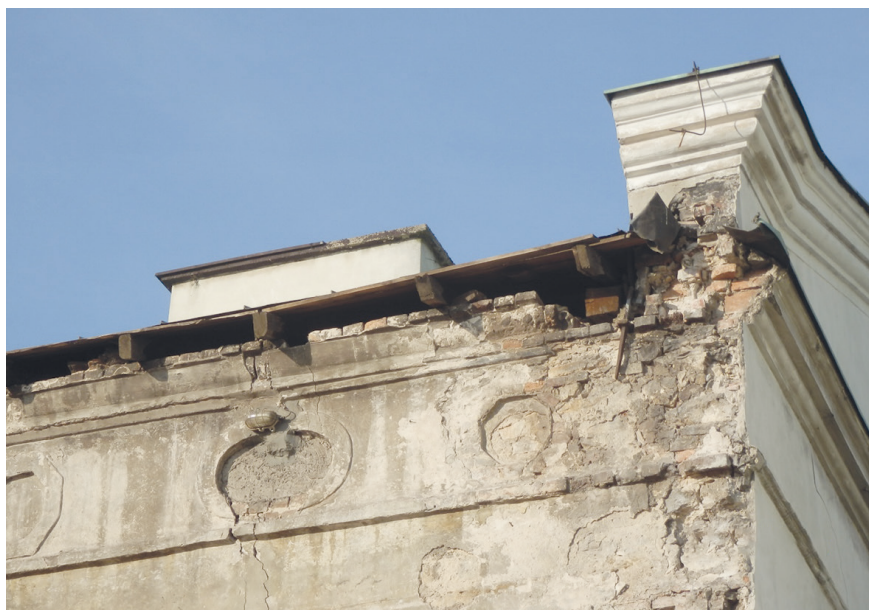
Fig. 10. Exposed drawing of the cornice together with the architectural detail of the historic monastery building. Photo by M. Błażewicz

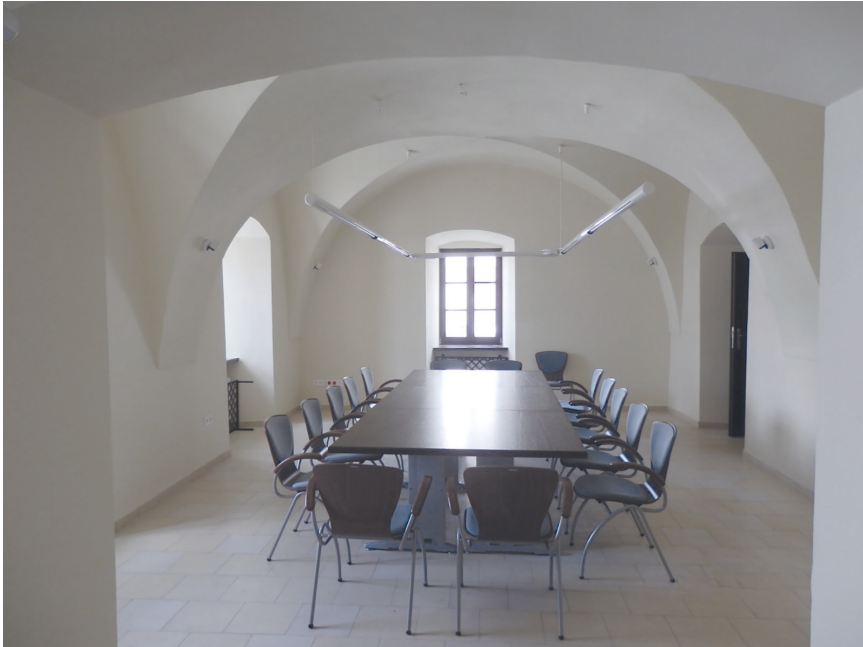
Fig. 11. On the first floor of the monastery building (15th century), a room was separated which served as a refectory. Currently adapted as a meeting room. Photo by M. Błażewicz

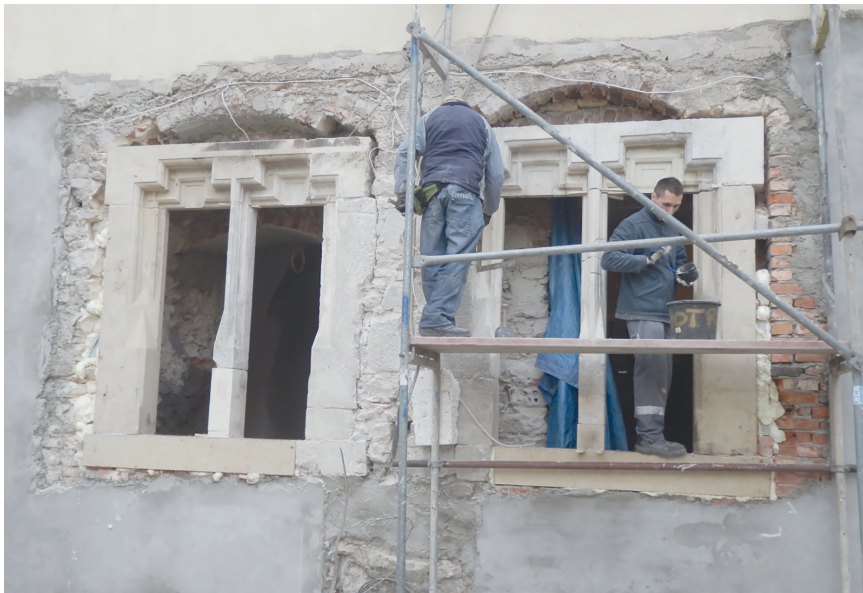
Fig. 12. Stone window frames in the eastern risalit — from the side of the cloister. Reconstructed on the basis of the preserved elements. The adaptation of historical details found during construction works could not be included in the project and thus did not fall under external funding. All such works had to be covered by the investor's own resources. Photo by M. Błażewicz

restoration project of the building [III; V]. The most valuable architectural element connected with the oldest monastery building are the two window frames in the eastern risalit from the side of the garth. They were reconstructed on the basis of the preserved elements (fig. 12, fig. 13). These elements were found in the stone wall structure of the building. They served as building material in the next construction phase [III; V].

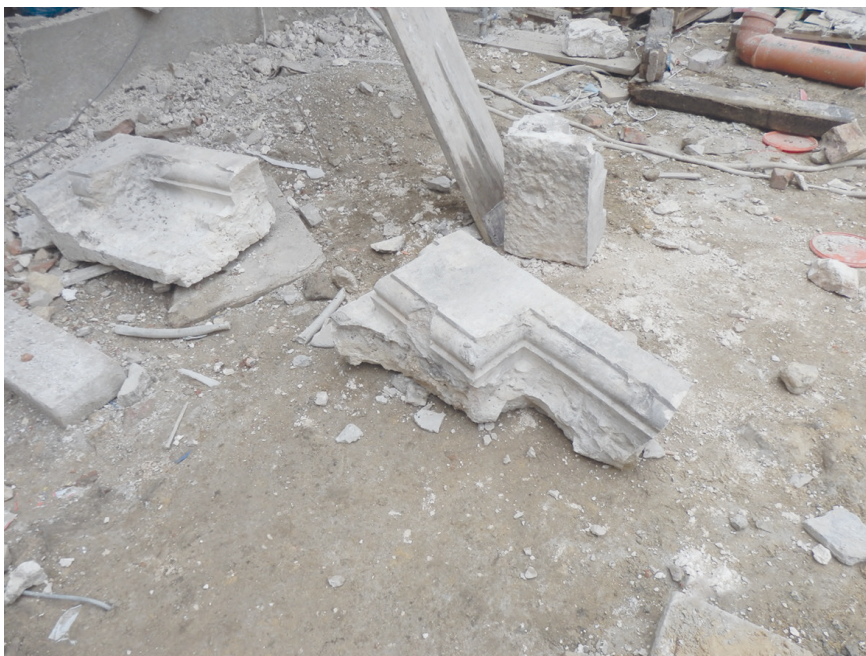
Fig. 13. Fragments of a stone window band. These elements were found in the stone wall structure of the building. They served as building material in the next phase of construction. Photo by M. Błażewicz

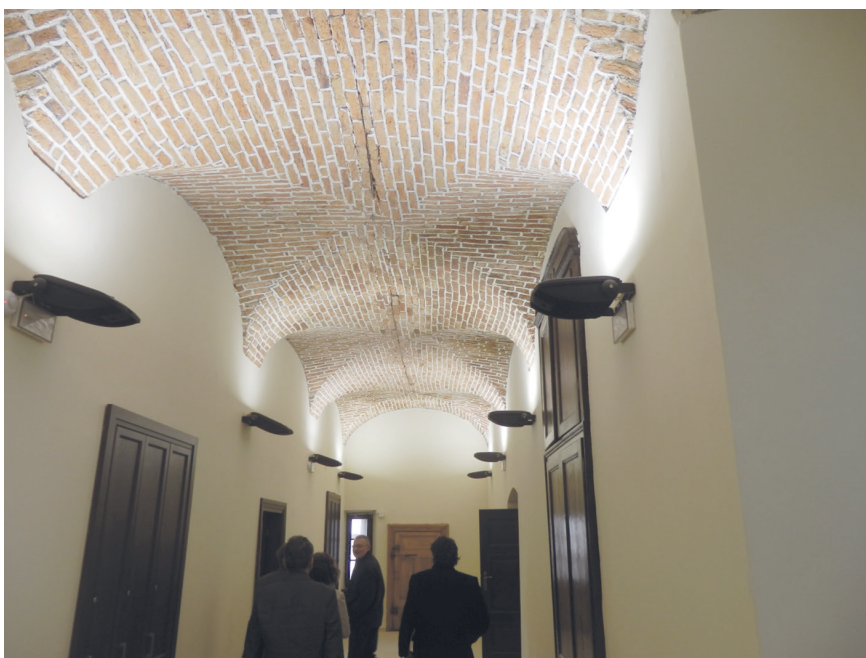
Fig. 14. The corridor tract on the east side was added in the 17th century. Wooden ceilings were replaced with brick cross vaults. In the realisation, the vault contrasts clearly with the walls to emphasise the difference in the time of their creation. Photo by M. Błażewicz

The second phase of the construction of the monastery took place in the middle of the 17th century. The original narrow building was extended by a corridor on the eastern side. Excavations carried out in the interior of the building confirmed these changes. In addition, the monastery was connected to the church building at first floor level by an arcade porch. In the interior of the building the wooden ceilings were replaced by brick cross vaults (fig. 14). The facade of the building was crowned with a crowning frieze. The flat part of the frieze contains a slightly profiled pattern of ovals and hexagons. Fragments of this frieze are preserved on the eastern façade (northern corner). They were discovered during demolition works.

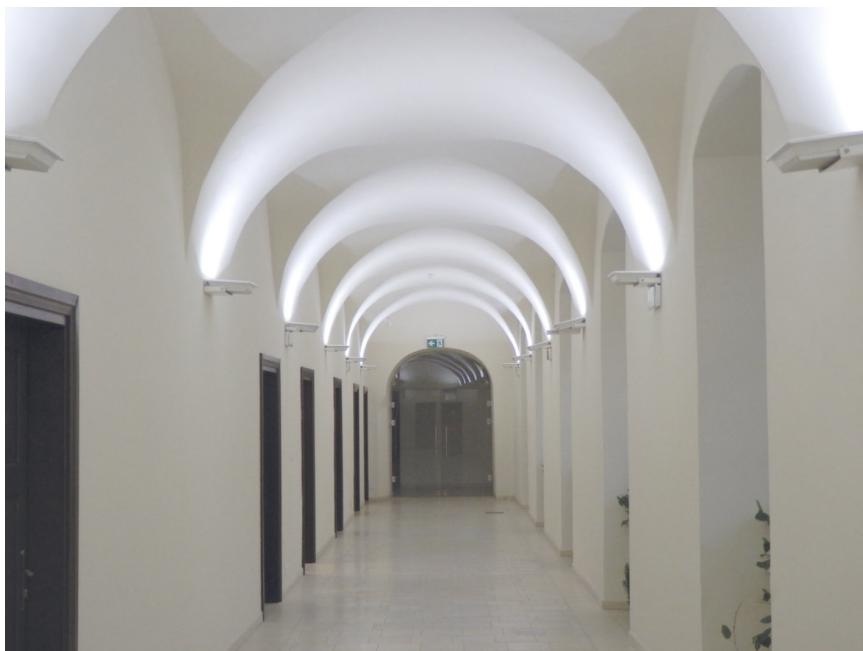
Fig. 15. The south wing of the monastery was added in 1729; the corridor is covered with barrel vaults with lunettes. Photo by M. Błażewicz

The last third phase of construction is the south wing of the monastery. The building dates back to 1729 and is a two-aisle structure with numerous rooms covered by barrel vaults with lunettes (fig. 15). The two-aisle building consists of a corridor on the north side and six rooms on the south side. This division is present on each floor. Both stories are connected by a brick staircase with vaulted landings. At the beginning of the 20th century (1905), a row of commercial rooms (fig. 16) was added to the west wing. The western facade was then covered with a thick layer of cement mortar. This covered the 17th century frieze crowning the facade [III; V].

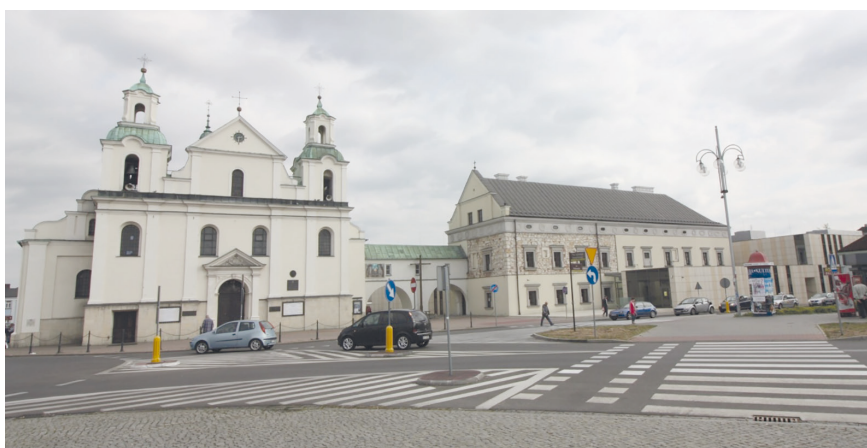
Fig. 16. The oldest wing of the monastery (15th century). Exposing a fragment of the wall as a “witness to history”. Photo by N. Sołkiewicz-Kos

The architectural and landscape research has made it possible to identify the historic values of the building. The project highlights three main phases of the transformation of the monastic complex. The 15th century phase was highlighted by the exposure of the stone wall structure in the north-west corner of the oldest monastery wing (see: fig. 16). This treatment provides a glimpse of the distinctive limestone masonry structure along with the exposed stone framing of window recesses blinded in later phases of construction. The conservation guidelines stipulated that the entire façade of the monastery complex should be plastered. No evidence remains as to whether the western wing of the monastery was plastered or not in this period. During construction work, numerous fragments of masonry were discovered showing repairs carried out at the time. Their nature may indicate that the stone structure of the external walls was uncovered. As a result of the new discoveries, the conservator allowed a fragment of the wall to be exposed as a “witness to history” [III; V].

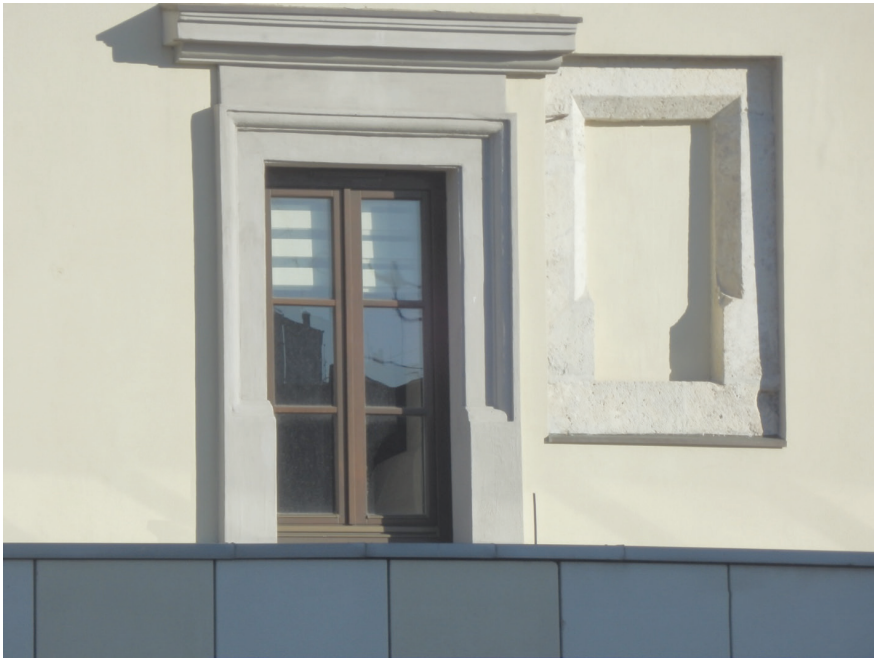
Fig. 17. The window frames that did not survive from that period were reconstructed. Frames from the same period in the Pauline Monastery in Priinczow were used as a model.
Photo by M. Błażewicz

The second phase, the 17th century, concerns the western wing. The frieze from the period of the reconstruction of the monastery in the 17th century led by Andrzej Gołdonowski, the provincial of the Pauline Fathers, was reconstructed. The window frames were reconstructed, no traces of which have survived to the present day. The frames from the same period were used as a model, from the Pauline monastery in Pińczów, which was also associated with Andrzej Gołdonowski at the time (fig. 17).

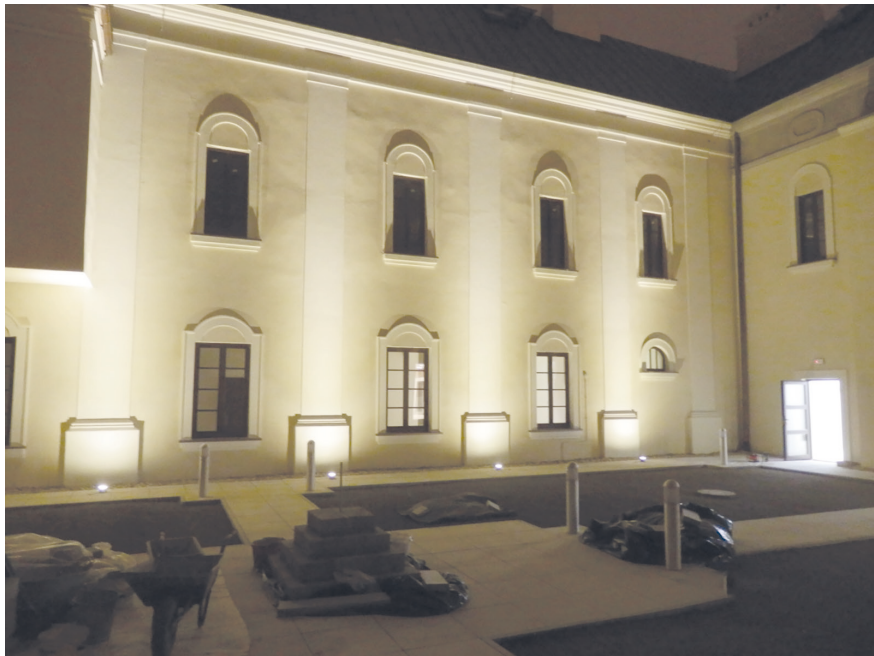
Fig. 18. The southern wing of the monastery, the reconstruction of the 18th century remnants of pilasters and the introduction of simple window frames. Photo by M. Błażewicz

The third phase, the 18th century, was emphasized by the restoration of the partially preserved moulded brick pilasters and the introduction of simple window frames in the south wing of the monastery (fig. 18) [III; V].

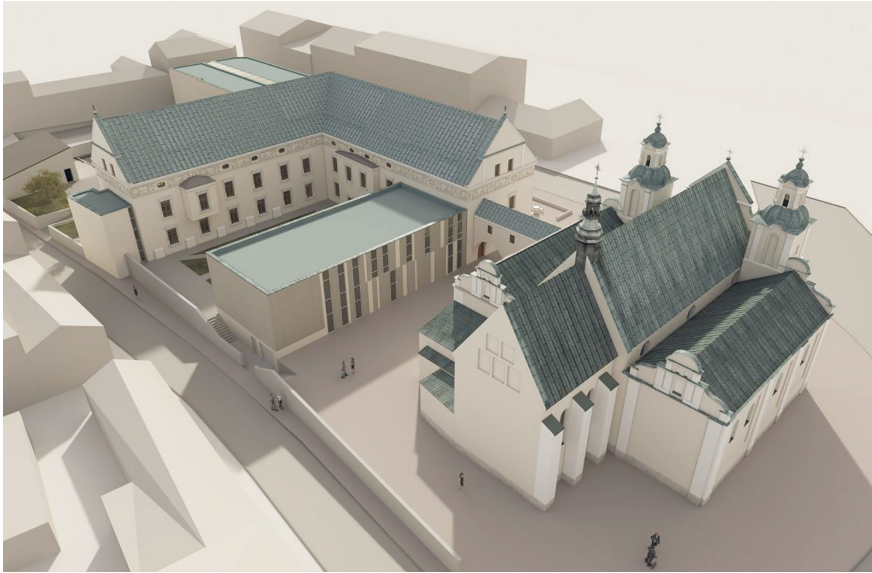
Fig. 20. Revalorisation project. View from the north-eastern side. Authors of the project: M. Błażewicz, S. Oset; visualization: P. Najwer

The new contemporary buildings introduced into the historic monastery complex emphasize the historical dimension of the space and respect the context of the surroundings. This was to facilitate the perception of the historic buildings against the background of the fourth dimension of space — time (fig. 19, fig. 20, fig. 21) [28]. The architectural

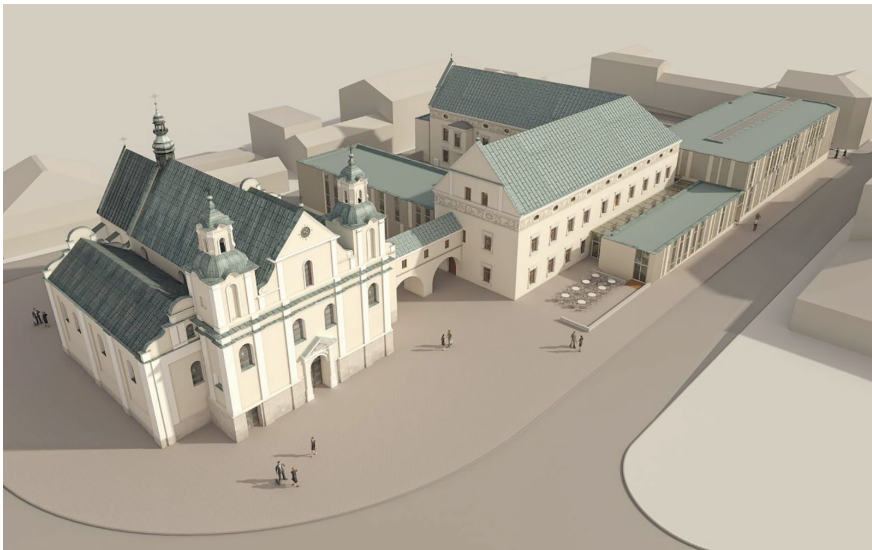
Fig. 21. Revalorisation project. View from the north-western side. Authors of the project: M. Błażewicz, S. Oset; visualization: P. Najwer

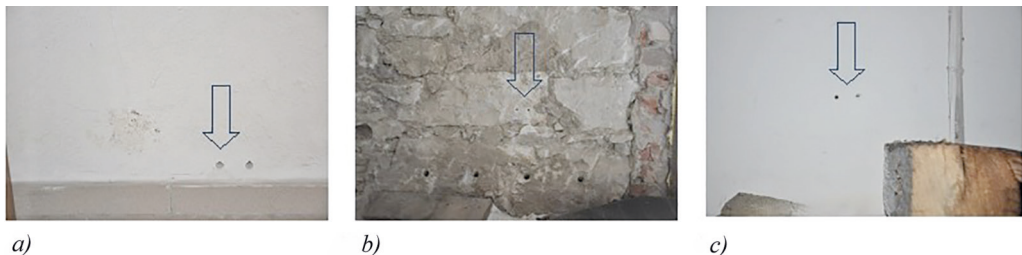
Fig. 22. Measurement points in a room: a) in the basement, b) on the ground floor, c) on the first floor

The research confirmed considerable dampness of the walls. The lowest mass humidity of the material inside the partition was found at the level of the first floor at 1.73%, which indicates that the material inside the external wall is practically dry. At the ground floor level, the mass humidity reached a value of 12.1%. This is a level of humidity which qualifies the masonry to be dried and protected against further dampness. The highest level of humidity in the external wall material was found at the basement level, exceeding 22%, which indicates persistent moisture as a result of capillary rise of water from the ground and the need to dry and protect against moisture (fig. 22) [VI] (see also indoor air parameters in the table).

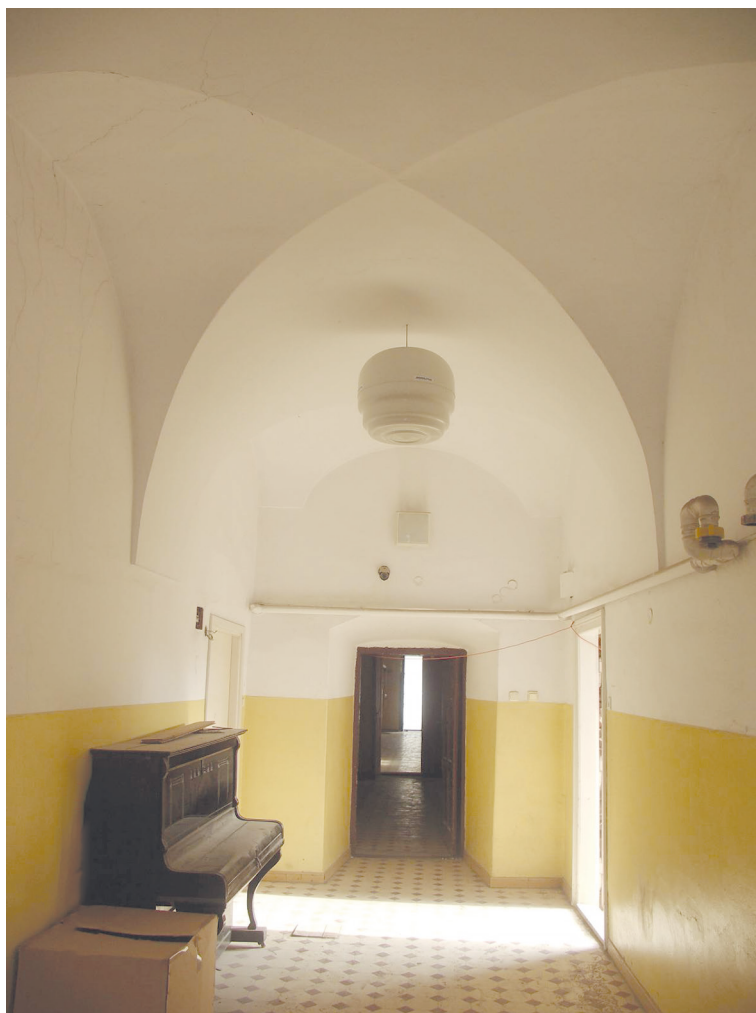
Fig. 23. Suspended from the vault, the device uses the gravitational field and the earth's magnetic field to stop capillary rise of water from the ground. Photo by M. Błażewicz

In the restoration project it was decided to use modern technology. A device was applied which uses gravitational field and magnetic field of the earth, which in effect is supposed to lead to withdrawal of water from the wall. The use of this system is expected to dry all the walls simultaneously to the natural moisture level (fig. 23) [32].
